ACCESS AUDIT OF A SPORTS CENTER

By: Sherihan Akkawi and Ramez Maadad

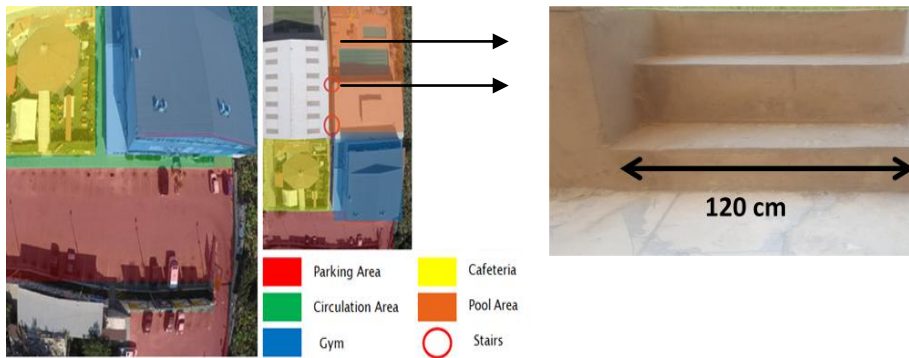
1. Plan and Distribution of Services

- Photo on the left shows the mass plan of the sports center from an elevated perspective. The picture also portrays the parking, gym, circulation, pool & cafeteria areas.
- Photo on the right shows the stairs leading to the pool & football field area. *No ramps are installed.*

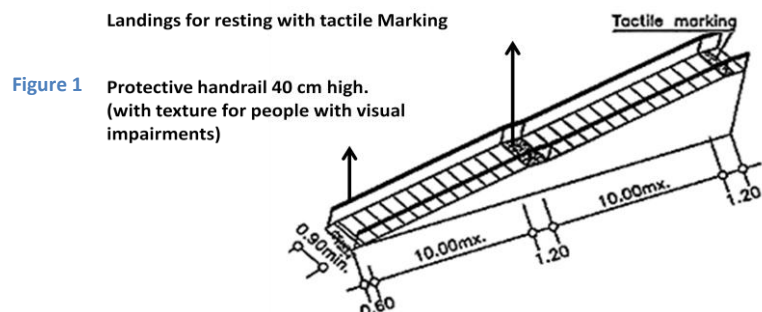
2. Outdoor stairs leading to the pool area

Problems Found	Suggested Solutions
1-Inaccessible routes for people with: <i>Mobility disabilities wheelchairs & carriages due to the lack of ramps.</i>	<ul style="list-style-type: none"> • Provide a ramp with landings for resting. (Fig 1) • Landings should be provided every 10.00 m. (Fig.1) • A protective handrail at least 40 cm high must be placed along the full length of the ramp.(Fig.1)
2-Inaccessible routes for people with: <i>Vision Impairments.</i>	<ul style="list-style-type: none"> • A colored textural indication (Tactile Marking) at the top and bottom of the ramp should be placed to alert sightless people as to the location of the ramp. (Fig.1)

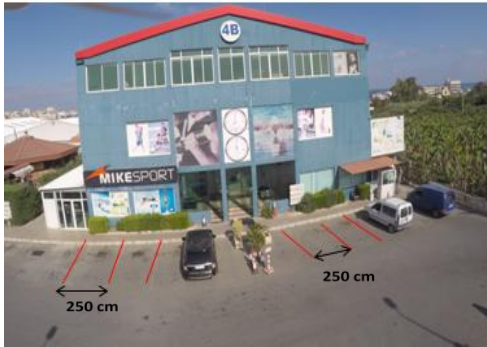
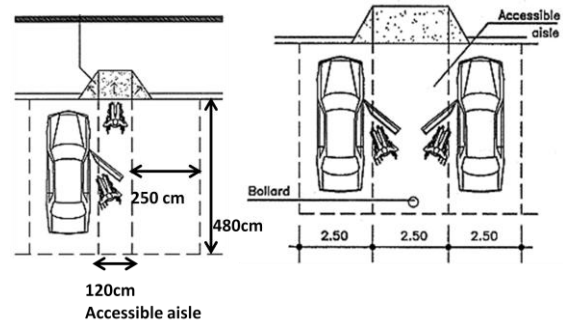
3. Parking

Problems Found	Suggested Solutions
1- Lack of Accessible aisle for people to place their wheelchairs.	<ul style="list-style-type: none"> Provide an access aisle 1.20 m wide located between two ordinary parking spaces as shown in the figure above. Place Bollards in Accessible aisle areas to prevent cars to enter the area.
2- Lack of signage to indicate parking for disabled people next to the entrance of the gym. (Fig.7)	<ul style="list-style-type: none"> Accessible parking spaces with appropriate signage should be located not more than 50 m from accessible building entrance. (Fig.2 & 3)
3- Lack of loading zones	<ul style="list-style-type: none"> Provide loading zone (120 cm length) (Fig.3)
4-No marking to indicate transition to a vehicular area between the parking and main entrance area for people with vision impairments.	<ul style="list-style-type: none"> Introduce a tactile marking strip at least 0.60 m wide can be constructed at the edge of the pathway to warn of the transition to a vehicular area.

5- Lack of curbed ramps for people with wheelchairs and carriages.	<ul style="list-style-type: none"> Construct a curbed ramp between the accessible parking & the main entrance area. (Fig.4)

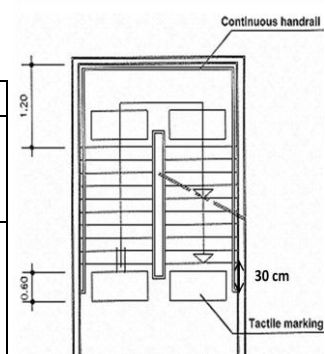
Figure 10

Problems Found	Suggested Solutions
1- There are no handrails on both sides of the stairs for people with mobility disabilities.	<ul style="list-style-type: none"> Handrails must be installed on both sides of the stairs and around the landing for gripping (fig. 10).
2- No Tactile marking strips on the stair landings.	<ul style="list-style-type: none"> A tactile marking strip should be placed at the top, bottom of the stairs and at intermediate landings to alert sightless people as to the location of the stairs.
3- The light coming from the window.

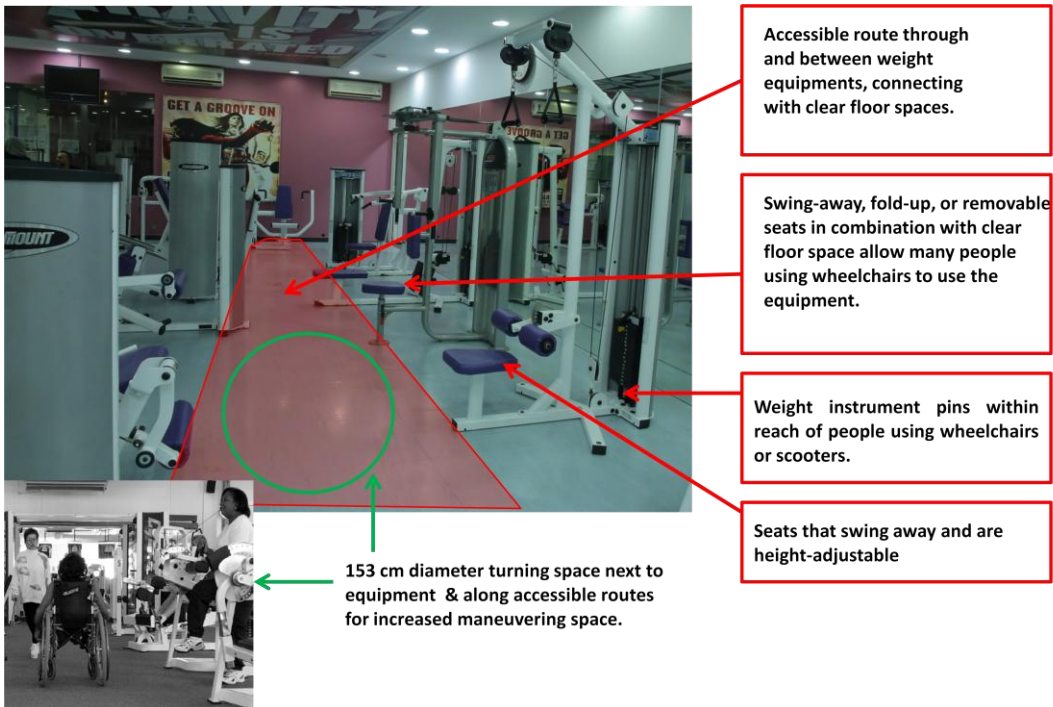
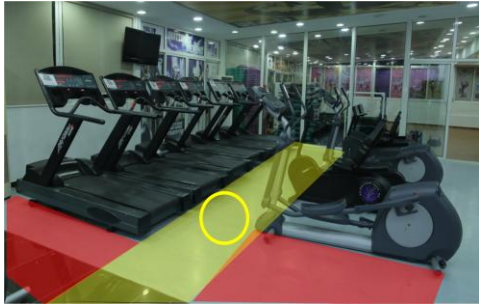
8. (Machines) Training Equipment Zone

Clear floor space, which may be used for people to leave walkers, etc., while using equipment. (120 cm x 46 cm)

• Accessible routes between all rows of equipment.

• 100 cm-diameter turning space between rows of equipment / If adjusted to 120 cm it will allow people to turn around without having to go to the end of the row.

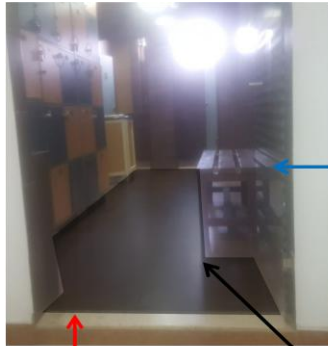
Bench should not encroach (make it narrow) on accessible route or clear floor space.

This step at the entrance of the Changing room, bathroom, locker and shower area is dangerous for people with visual impairments and inaccessible for people with wheelchairs.

The 100 cm narrow route should be widened to allow access of more than 1 person at a time and for people with wheelchair to be able to access it.

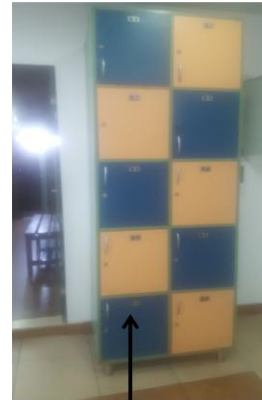
Lockers available on various height levels suitable for people with different height reach . (137 cm max for people with wheelchair)

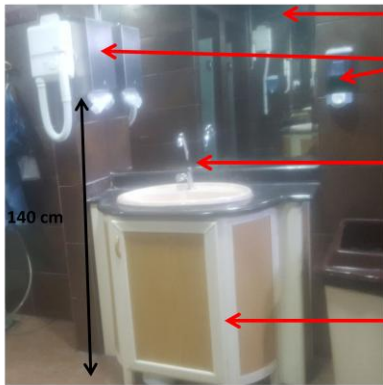
11. Lavatory

Mirror 100 cm above the floor.

Soap ,towel dispensers and hairdryer within reach and easy to use. (140 cm high from floor)

Lever faucet handles are not easy to use and require no grasping or pinching grip

Lack of knee and toe space with protective panel to prevent accidents under the lavatory.

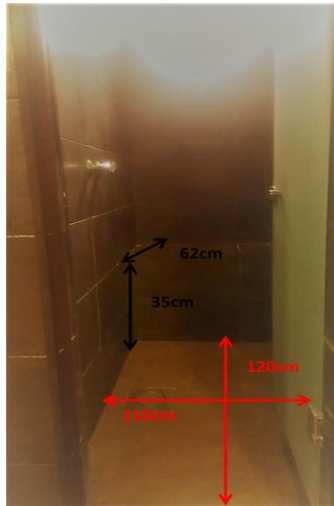
Figure 4. Dressing Room

Problems Found	Suggested Solutions
1-No full length mirror for standing & seated users.	Provide a mirror with the suitable measurements.
2-The door swings indoors.	Door swings outdoors.
3- No enough space for users with wheelchairs to maneuver.	Space should be 150 cm minimum & 180 cm to be comfortable.

- I. Large dressing bench 62 cm deep by 110 cm wide and 35 cm above the floor.
- II. Cloth hook is 120 cm high from floor.
